**Proposed Harmony Ridge Subdivision  
Old Pacific Highway  
Kalama, Washington**

**March 1998  
Project No: L98-0118**

Re: Geotechnical Evaluation for the Harmony Ridge Subdivision, Old Pacific Hwy, Kalama,  
Washington

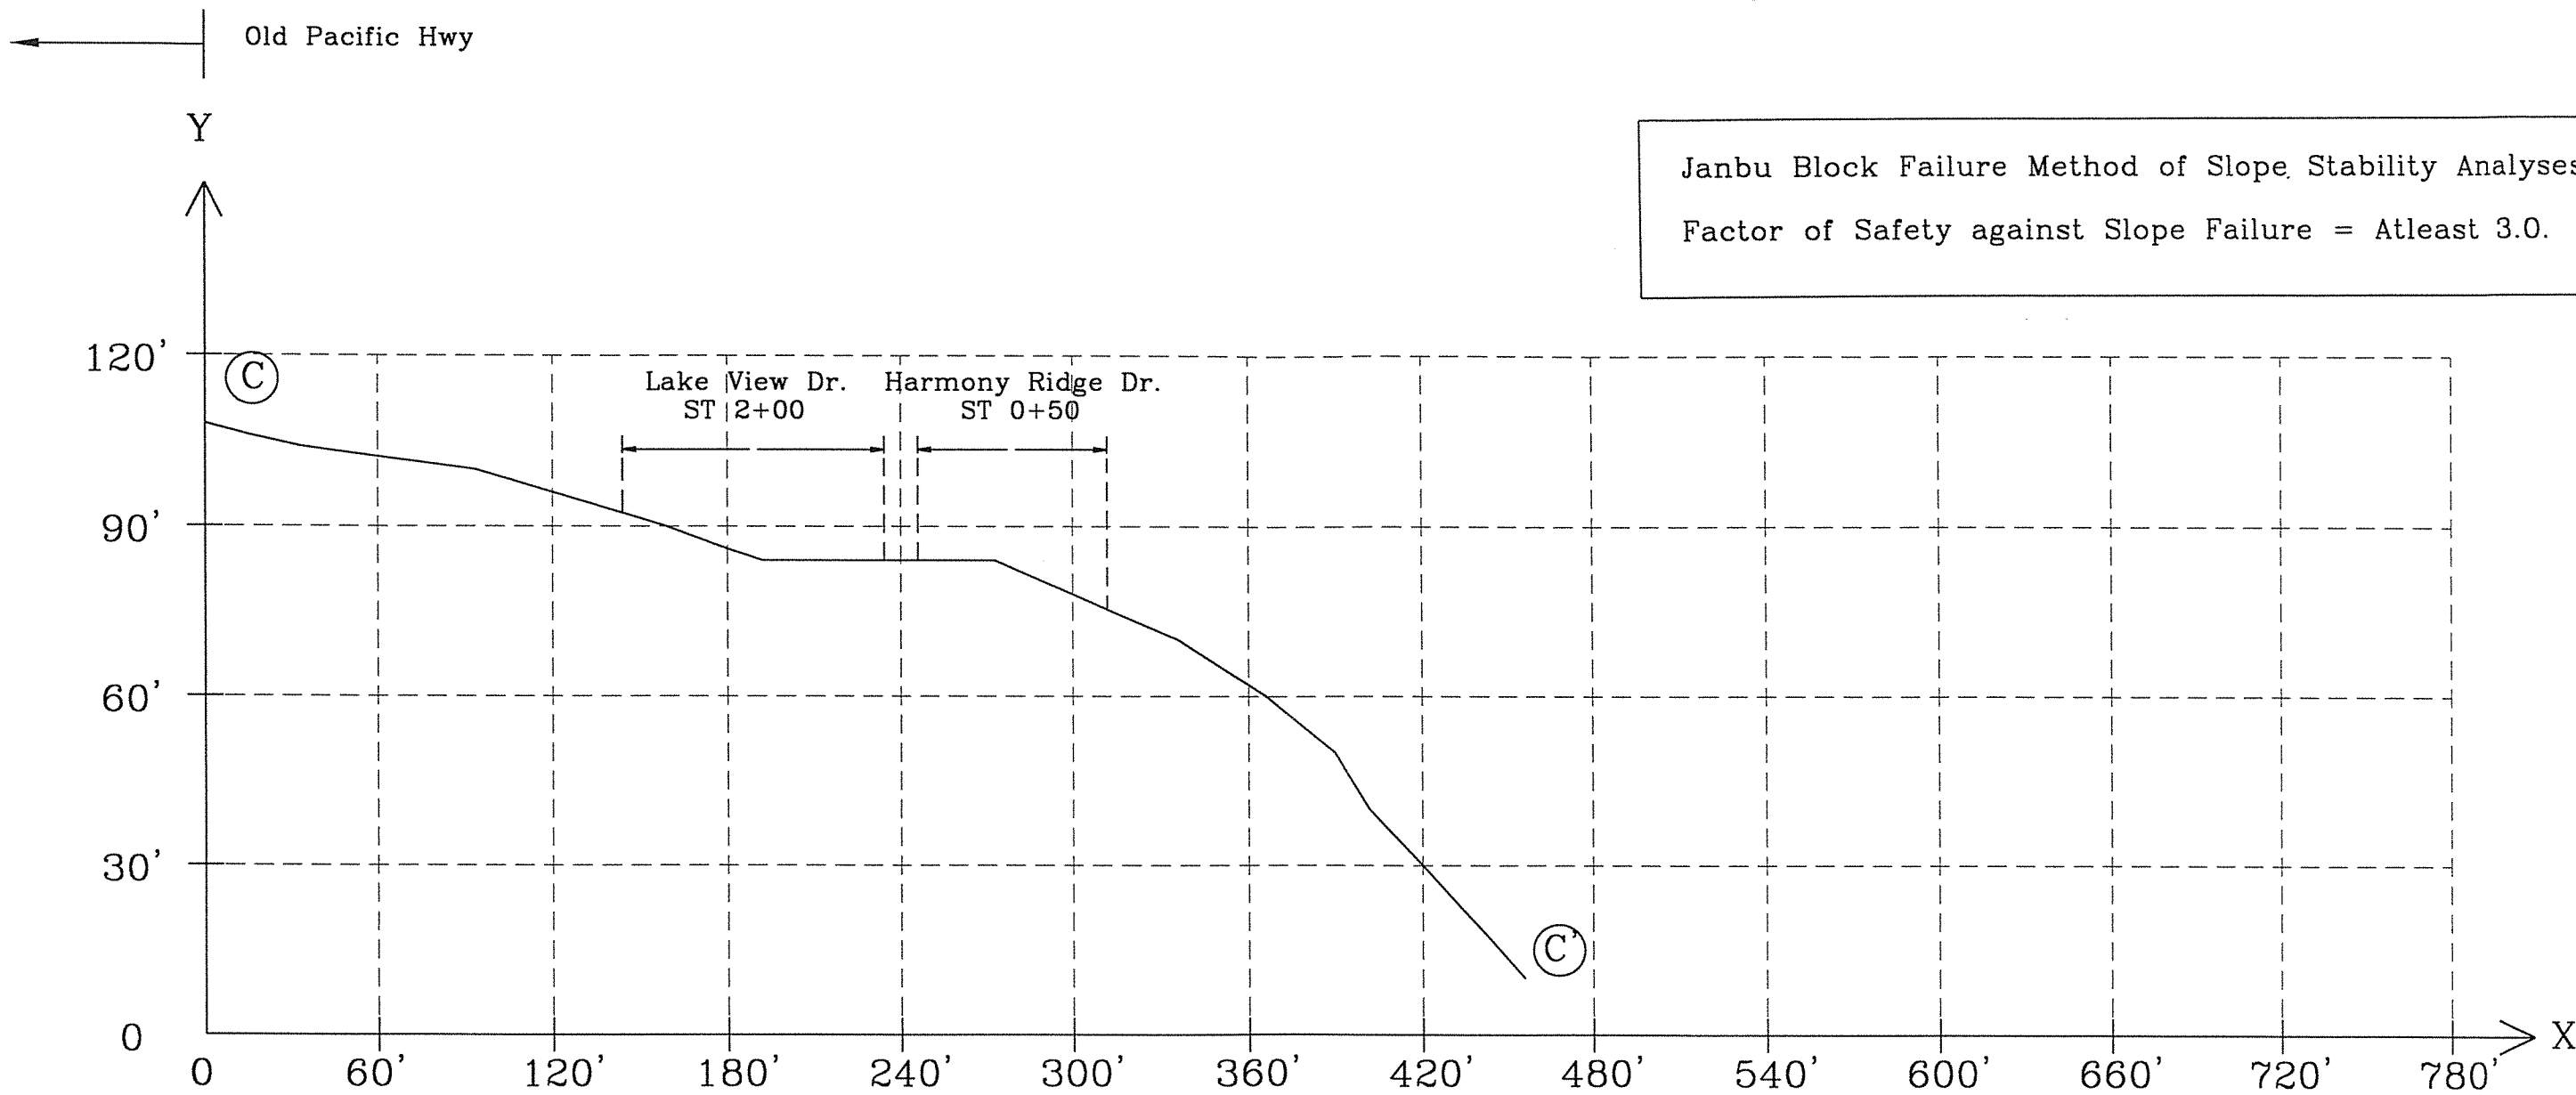
Cross-Section C-C'  
 Horizontal: 1 inch = 60 ft.  
 Vertical: 1 inch = 30 ft.

Janbu Block Failure Method of Slope Stability Analyses  
 Factor of Safety against Slope Failure = Atleast 3.0.

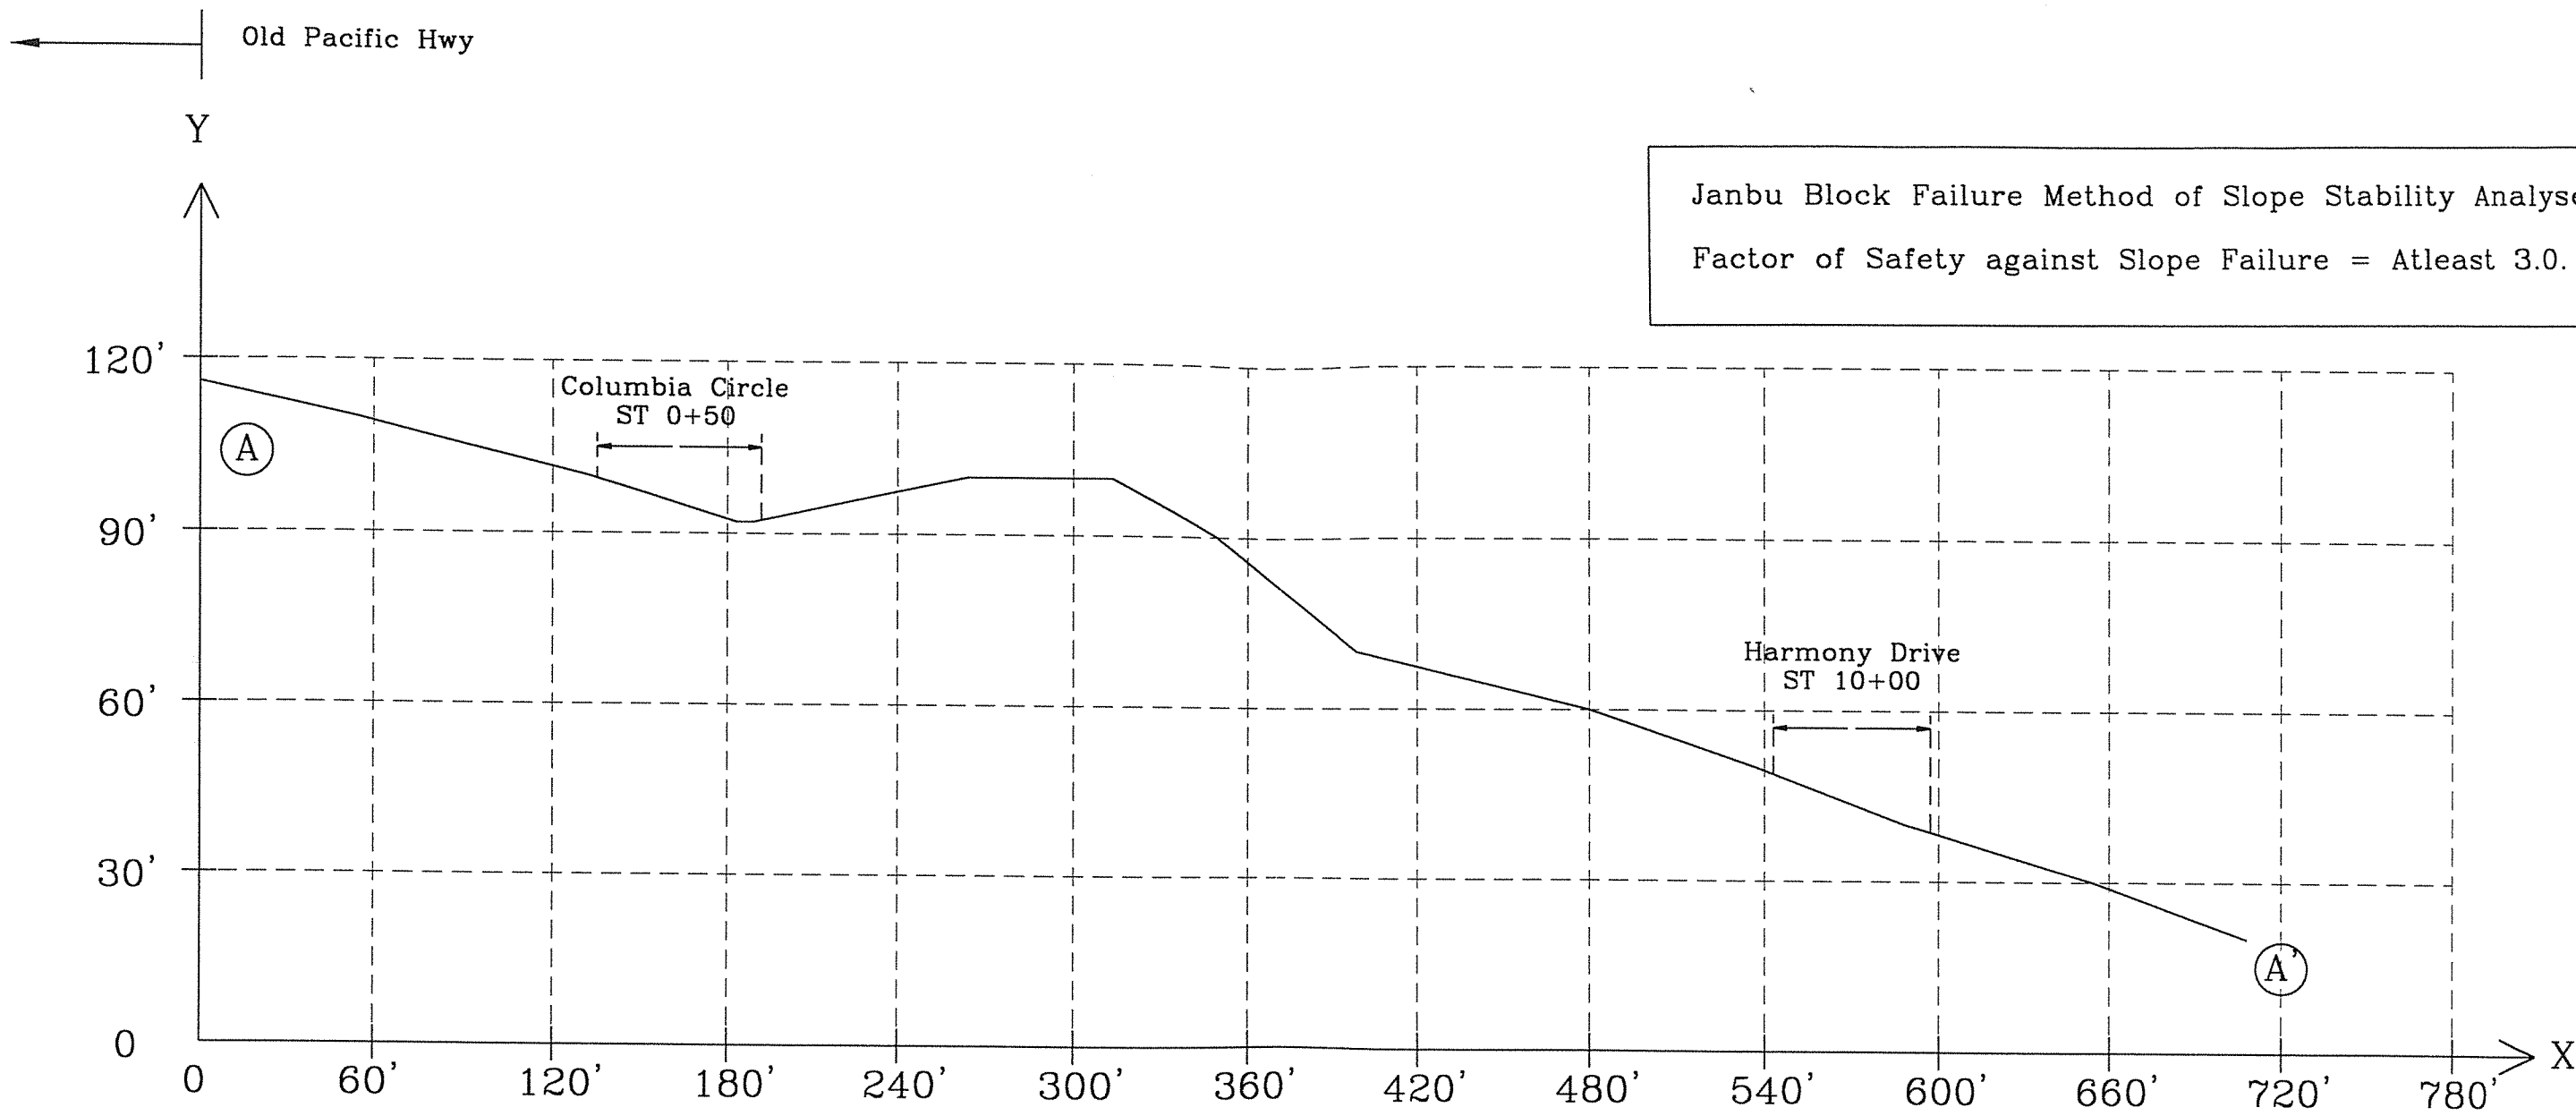
Cross-Section A-A'  
 Horizontal: 1 inch = 60 ft.  
 Vertical: 1 inch = 30 ft.

Janbu Block Failure Method of Slope Stability Analyses  
 Factor of Safety against Slope Failure = Atleast 3.0.

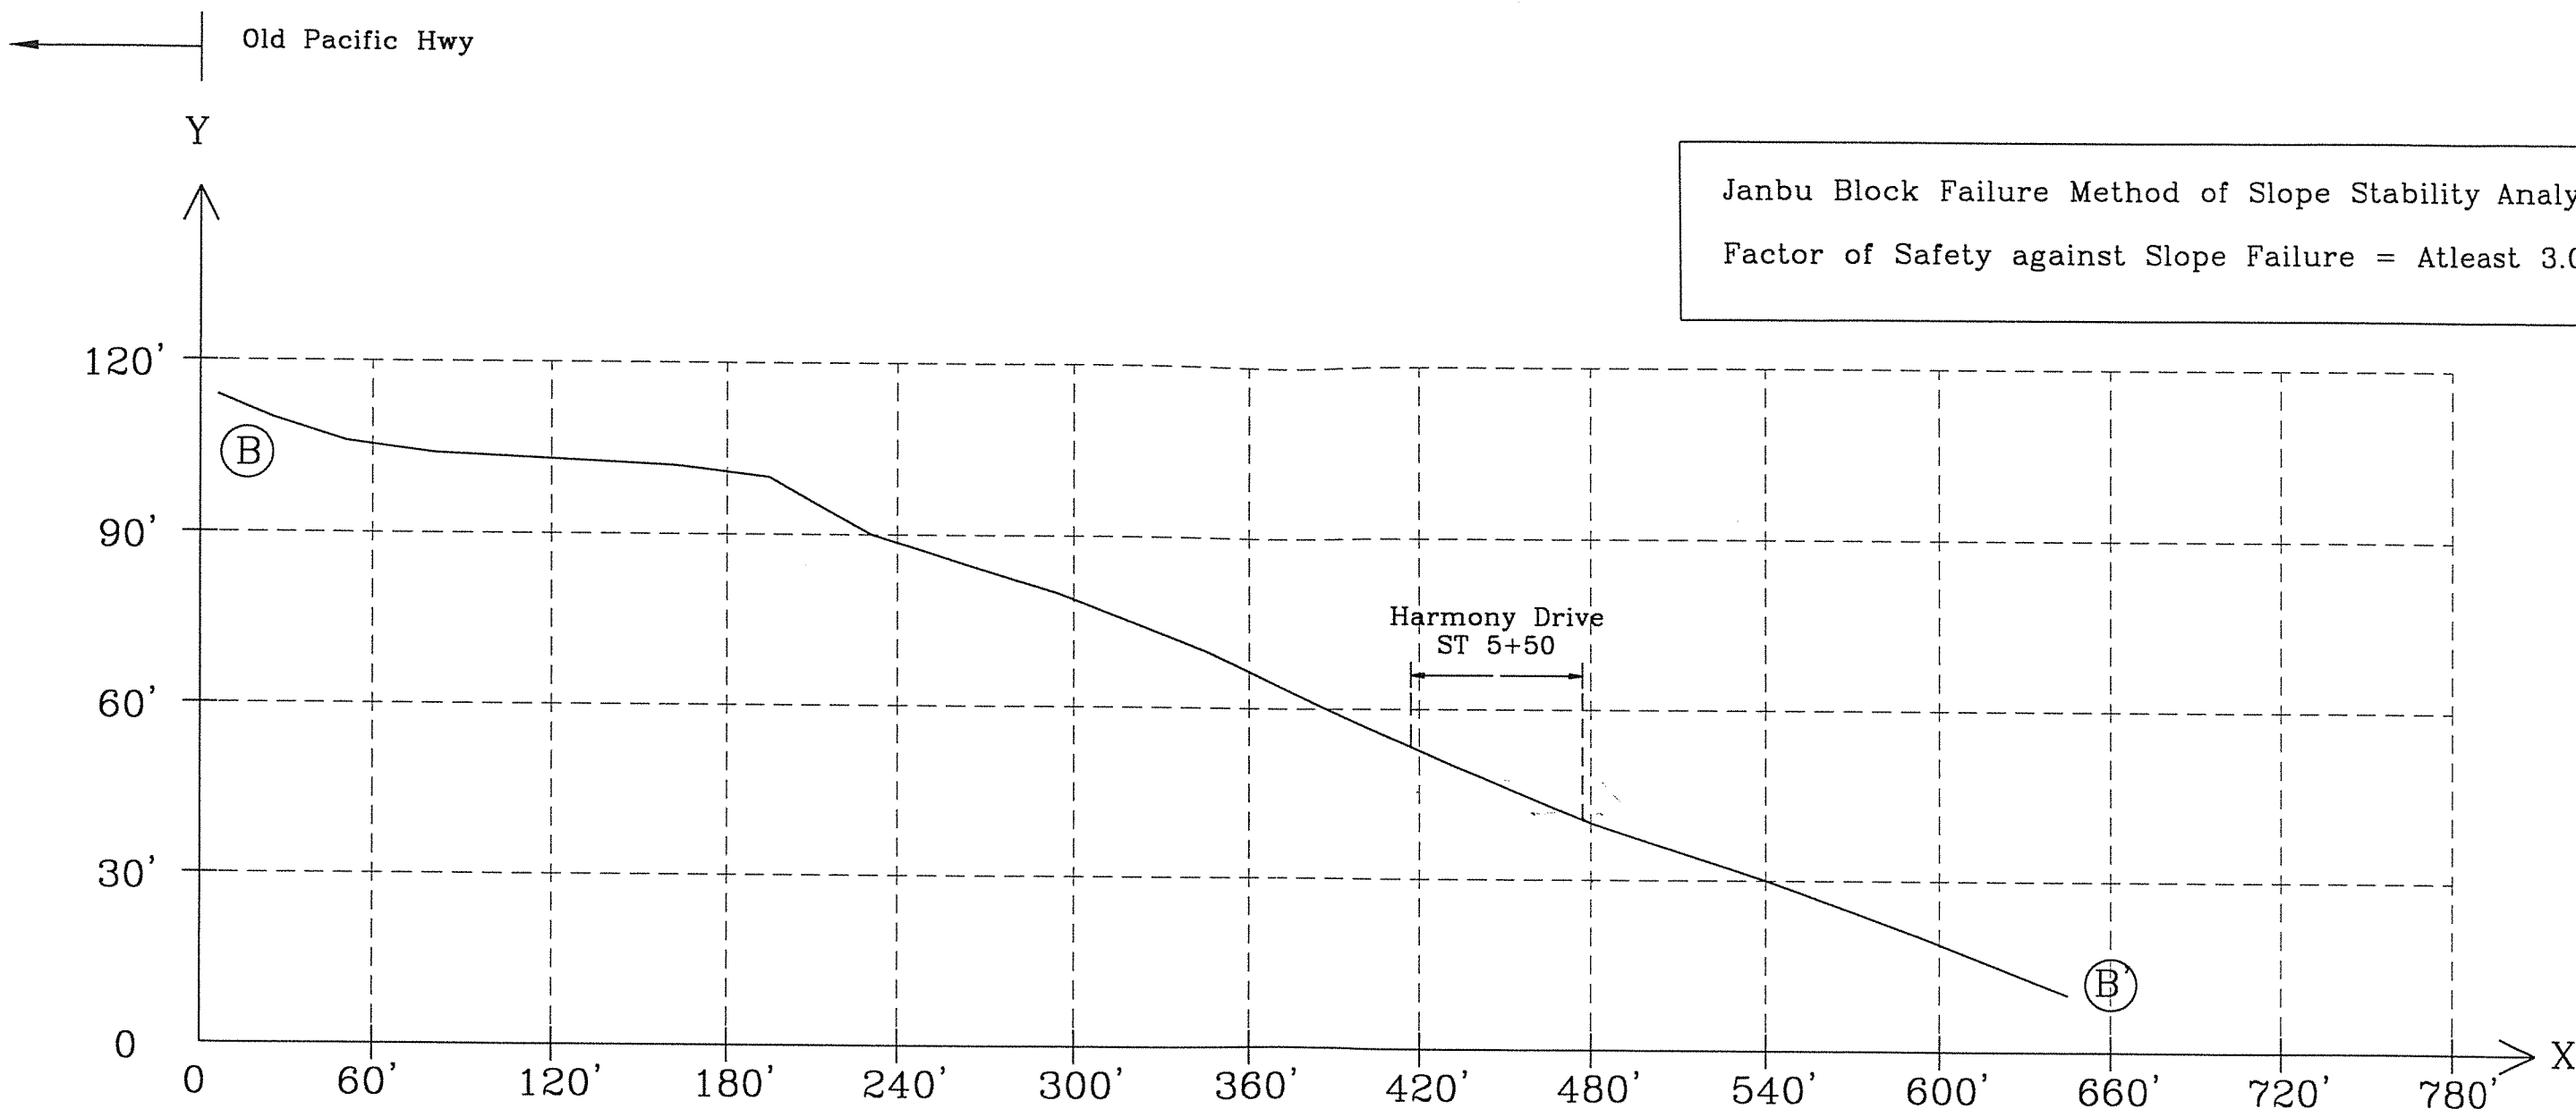
Cross-Section B-B'  
 Horizontal: 1 inch = 60 ft.  
 Vertical: 1 inch = 30 ft.

Janbu Block Failure Method of Slope Stability Analyses  
 Factor of Safety against Slope Failure = Atleast 3.0.

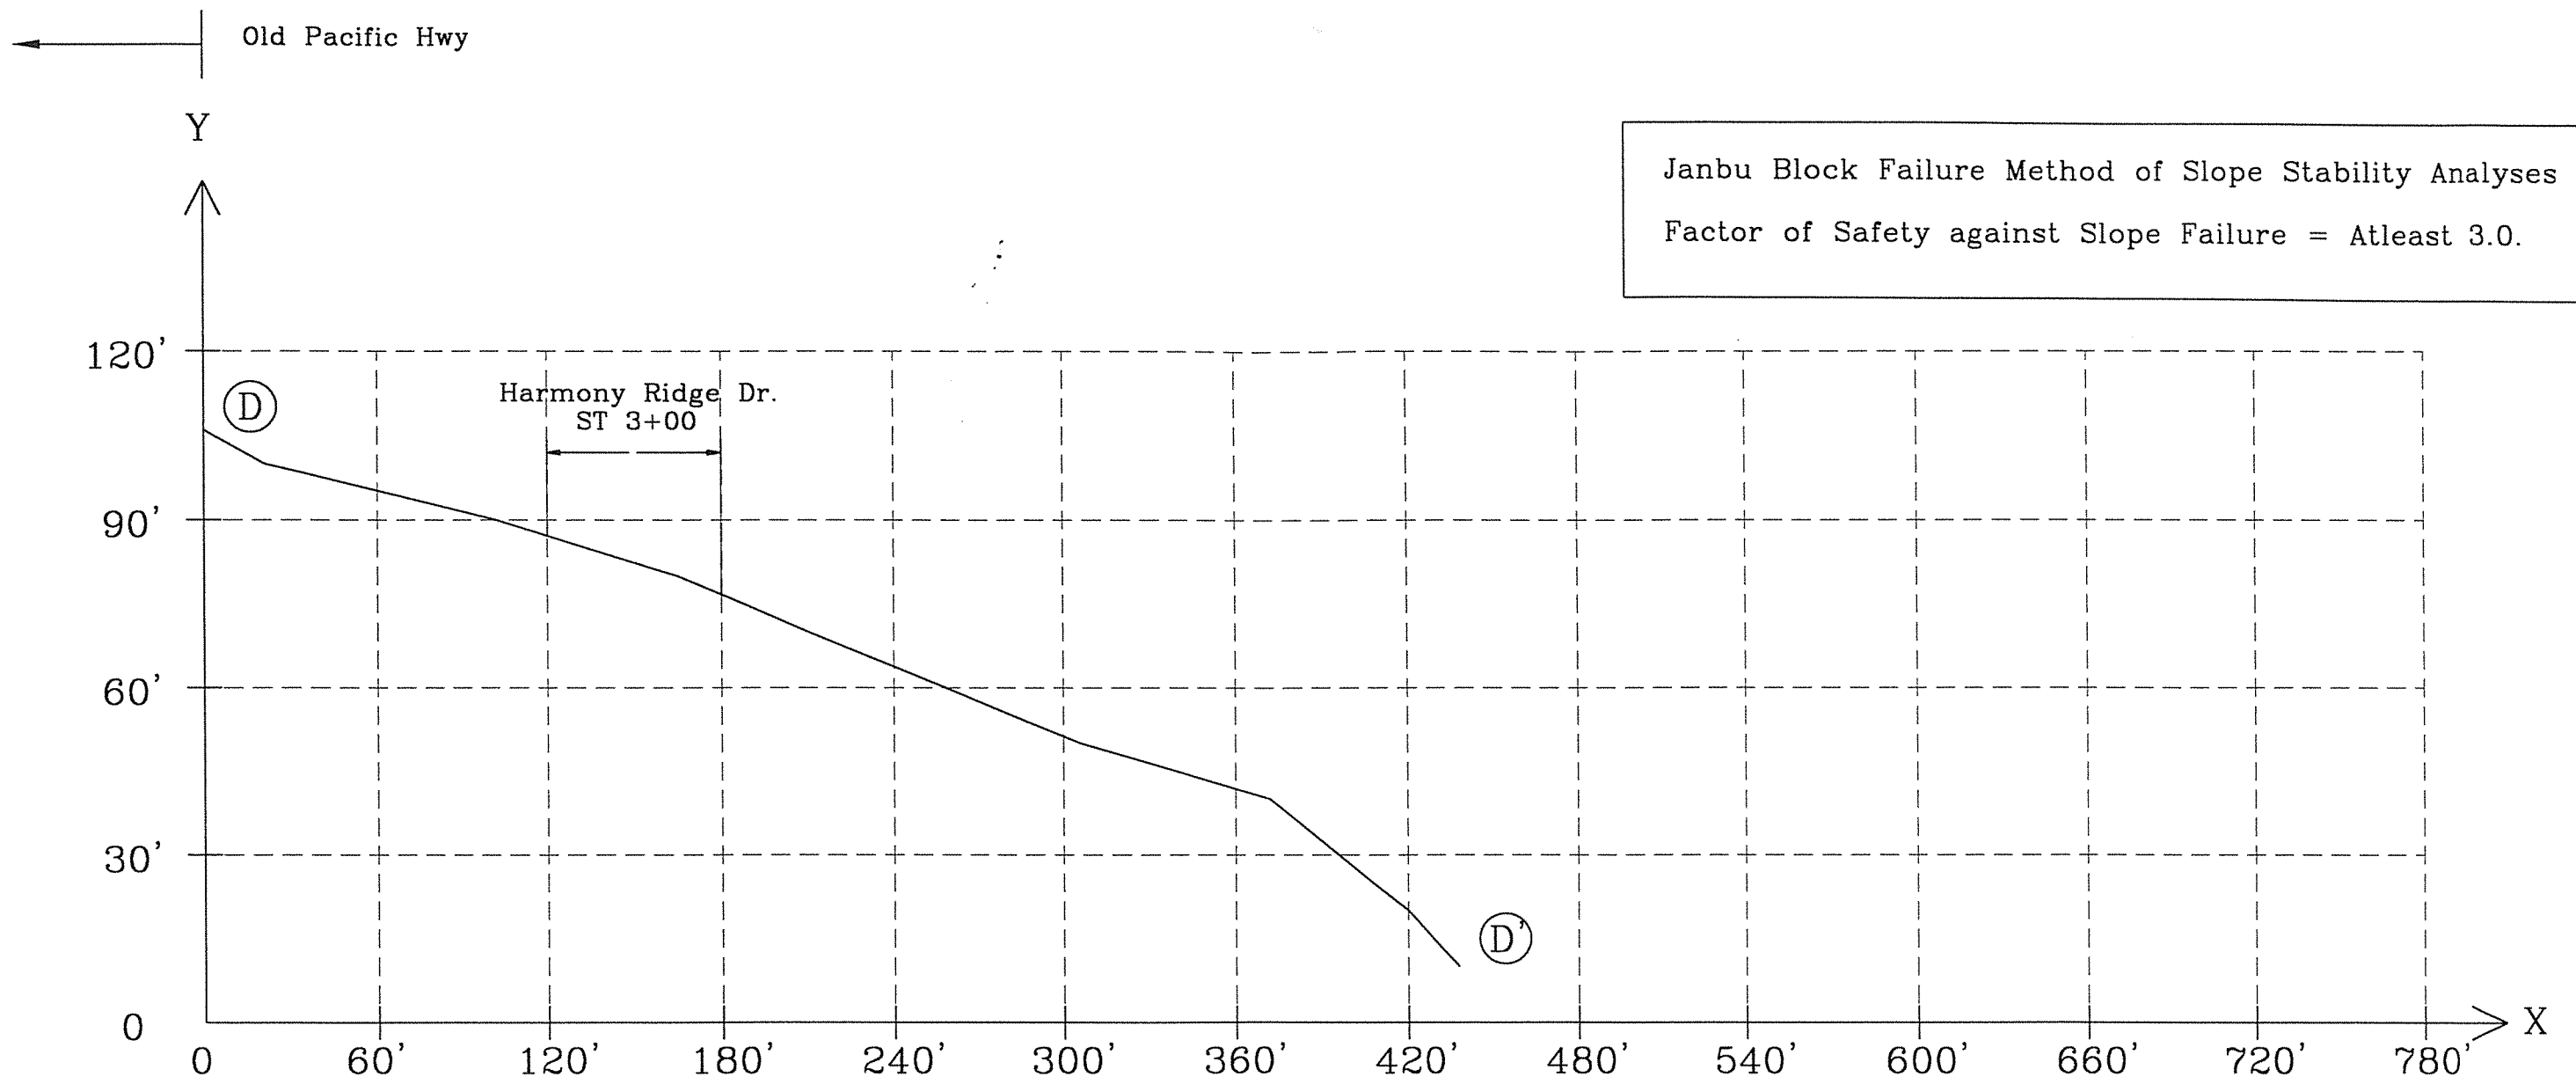
Cross-Section D-D'  
 Horizontal: 1 inch = 60 ft.  
 Vertical: 1 inch = 30 ft.

Janbu Block Failure Method of Slope Stability Analyses  
 Factor of Safety against Slope Failure = Atleast 3.0.
