ARCHAEOLOGICAL SERVICES

MEMORANDUM

RE: Updated plans for the removal of piles at the Port of Kalama T-Barge Facility project area, Cowlitz County, Washington

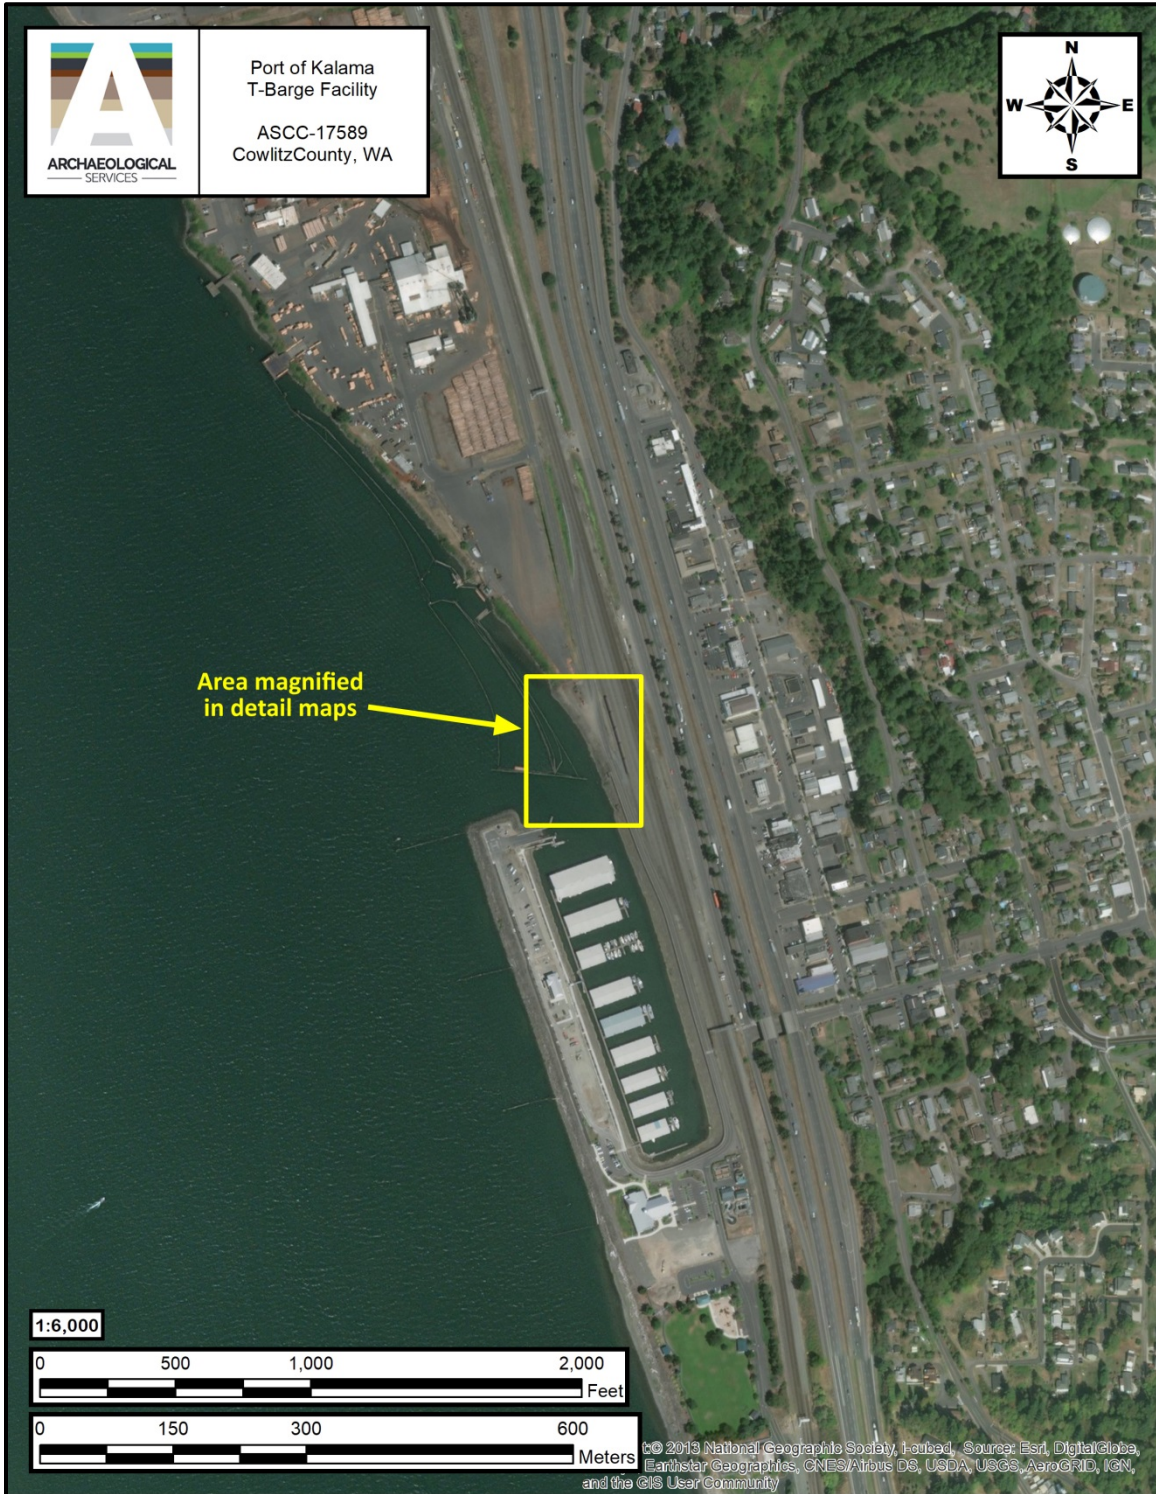
Figure 2. Aerial photomap showing an overview of the project setting and the configuration of detail maps in Figure 3 and Figure 4.

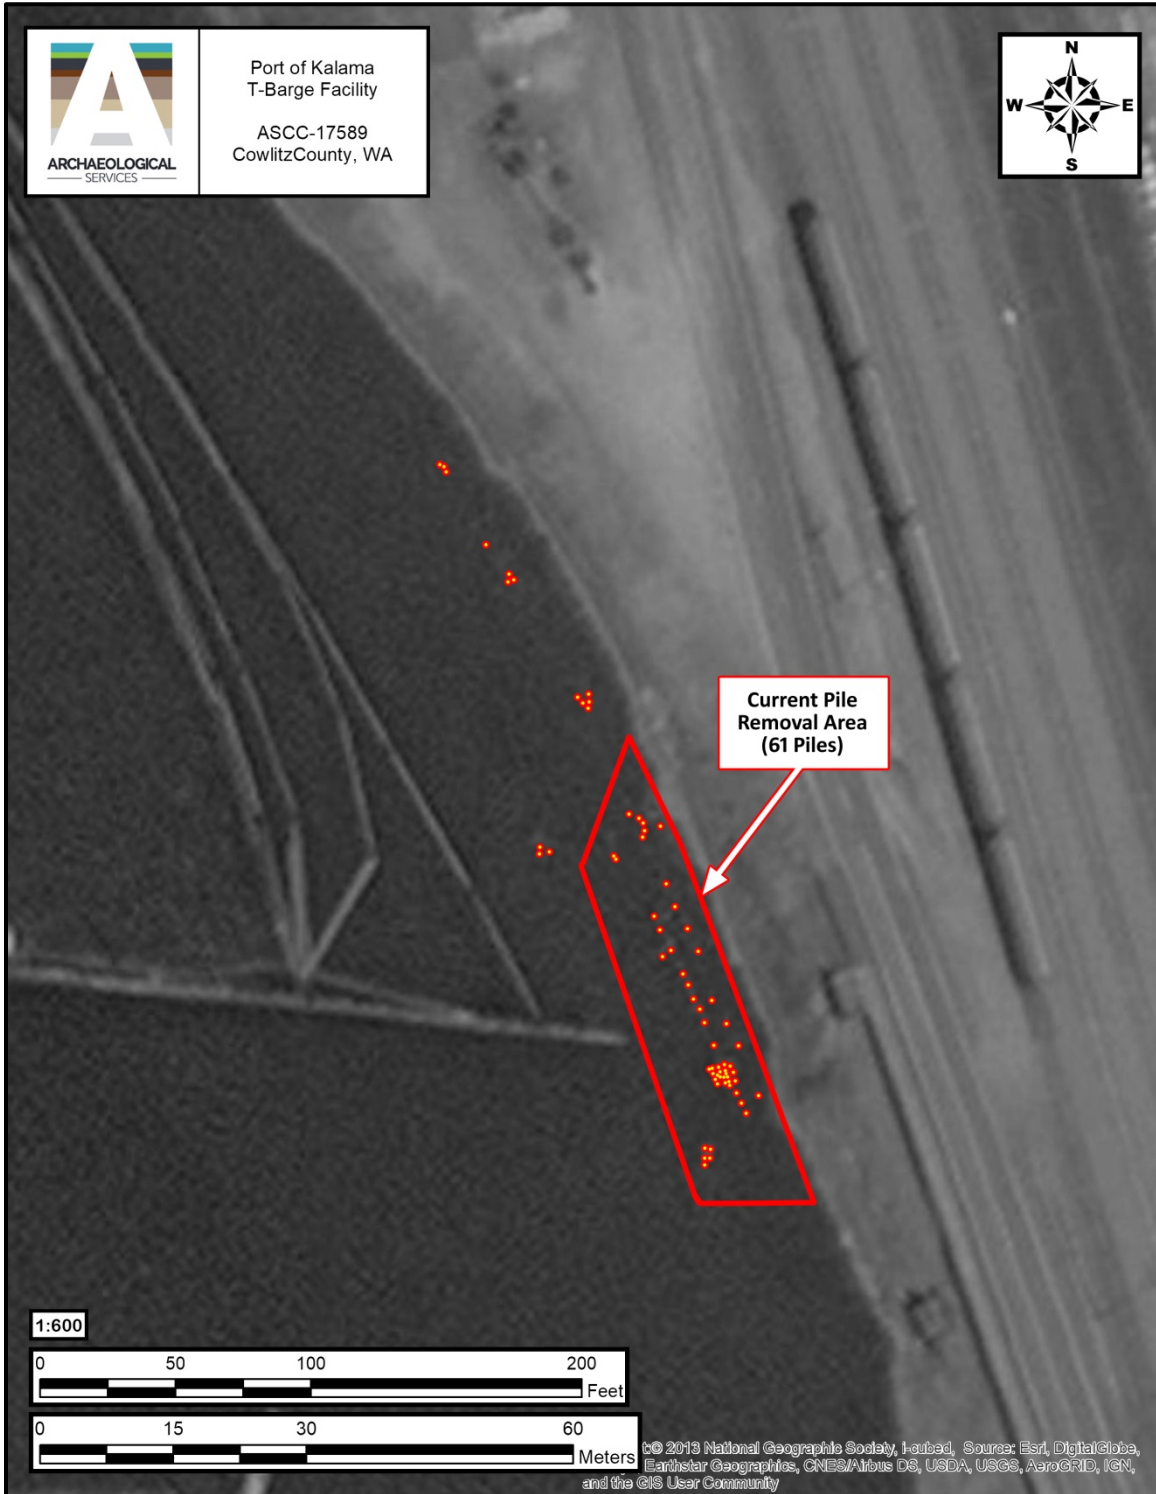
Figure 4. Aerial photomap showing the piles currently slated for removal (including 61 historic timber piles) per the updated project design.

This memorandum addresses the cultural resource implications of the proposed removal of piles from the Port of Kalama T-Barge Facility project area. The project concerns the placement of a floating T-barge along with access and utility infrastructure in NE $\frac{1}{4}$ of Section 18, Township 6 North, Range 1 West, Willamette Meridian, on the Columbia River shoreline within the city of Kalama, Cowlitz County, Washington (Figures 1 and 2). When the project was first brought to the attention of Archaeological Services, LLC (ASCC) in 2017, the proposed work entailed the removal of an estimated 80 derelict, creosote-treated timber piles, all over 50 years of age (Figure 3). The number of piles slated for removal was reduced to 10, but out of concerns for navigation safety, plans were revised again and now call for removing a total of 61 historic timber piles and 2 modern steel piles (Figures 4-7).

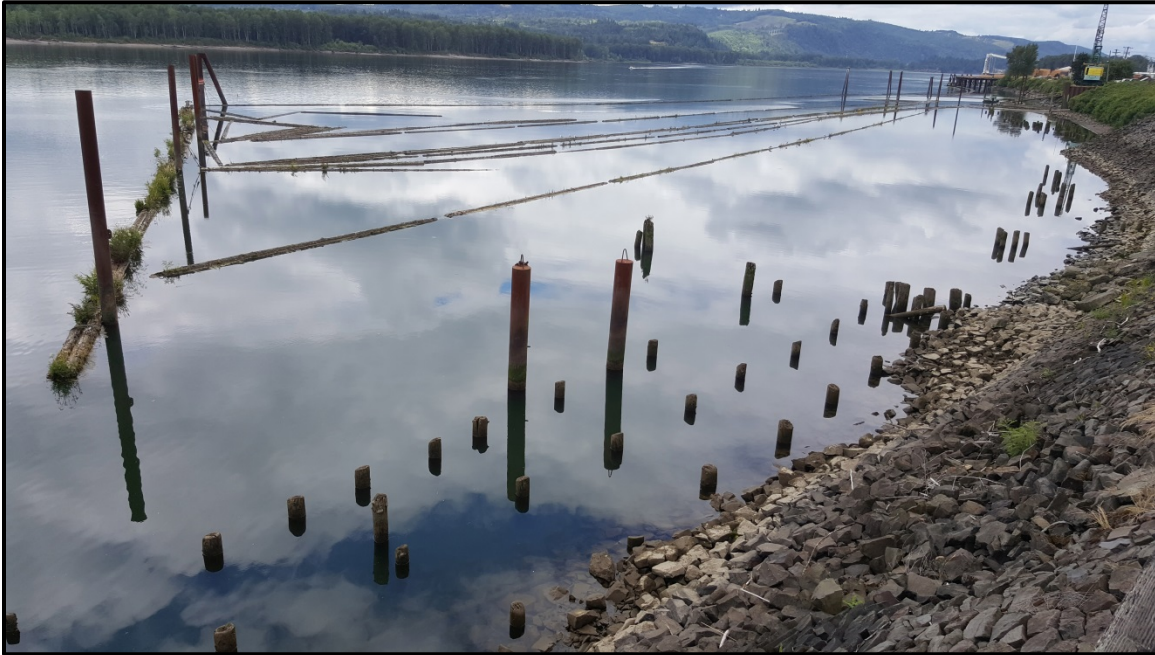
Figure 6. Northwest-facing view of the northern piles proposed for removal, with the two steel piles at photo center.

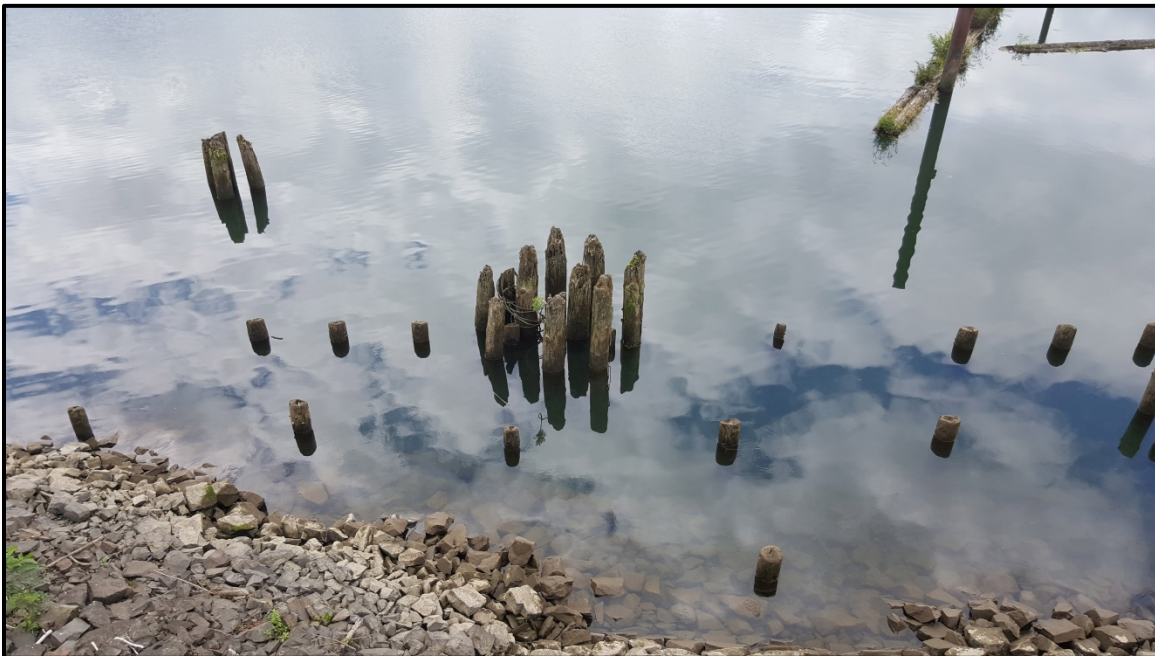
Figure 7. Southwest-facing view of the southernmost piles proposed for removal.

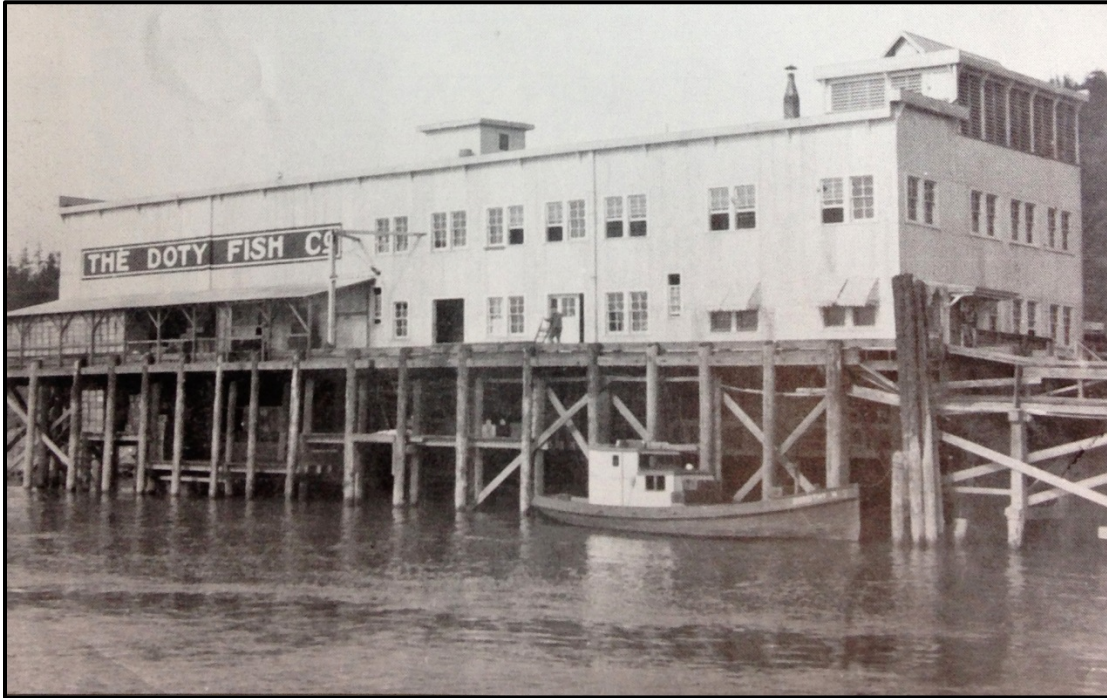
Figure 9. Undated, northeast-facing photograph of the rebuilt Doty Fish Company building/dock structure, taken sometime after the original building was destroyed by fire in 1924 (Thomas 2016:48). The currently proposed pile removal area is located to the immediate north of this location (photo left).

building is shown on the 1951 aerial in Figure 8, overlaid with the current project area. The accuracy of this overlay is imperfect, due to the geometric distortion of the aerial, but it does appear that the southernmost cluster of derelict piles could be the remains of a dock-corner dolphin similar to that shown in Figure 9. The dolphin in Figure 9 once stood at the southwestern corner of the Doty Fish Company dock and apparently served both mooring and structural purposes, suggesting that there may have been a counterpart at the dock's northwestern corner.
